**EMERGENCY SPILLWAY  
PERFORMANCE AT SITE 39,  
UPPER BLACK BEAR CREEK  
WATERSHED, OKLAHOMA**

**ARS-S-109  
March 1976**

By W. O. Ree<sup>1</sup>

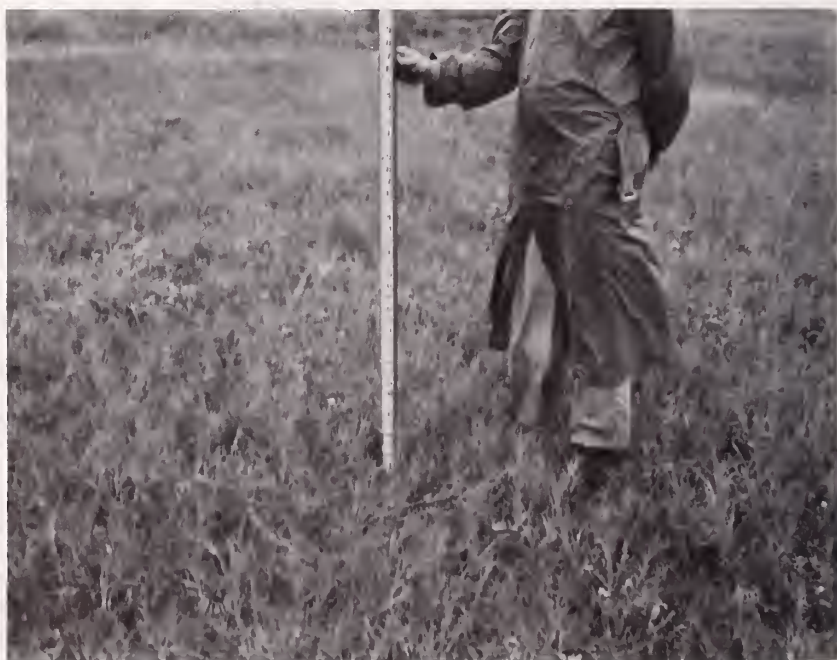
The grass in the spillway was in fair to good condition and was about 8 inches tall (fig. 3). Coverage was complete and fairly uniform except for a strip along the left side and a strip along the lower right side (facing downstream). The retardance class for the grass was estimated as being between a C and a D.<sup>2</sup>

FIGURE 3.—Bermudagrass cover on crest of emergency spillway.

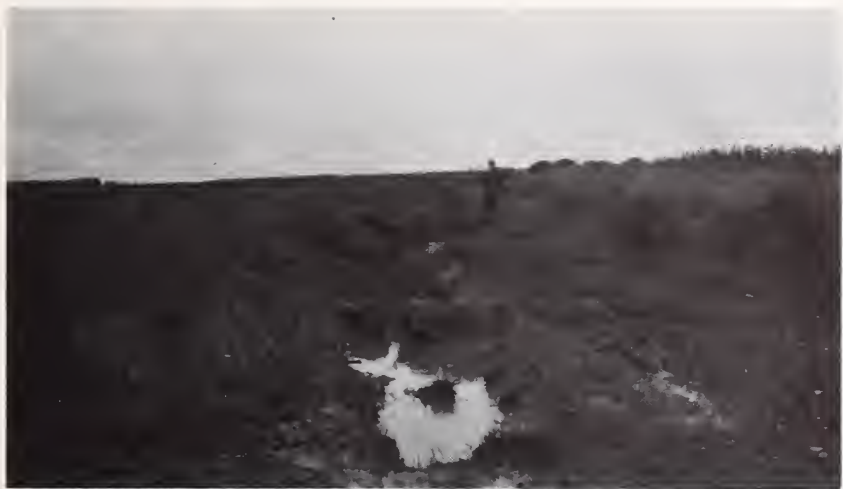
FIGURE 4.—Gully about 100 feet long by 7 feet wide by 2 feet deep along left side of emergency spillway.

Erosion along the left side had formed a gully about 100 feet long by 7 feet wide by 2 feet deep (fig. 4). Upstream of this gully, a barren strip with some sheet erosion extended up to and over the spillway crest. There was no vegetation along the left side of the crest for a width of about 6 feet. Just outside the spillway and on the left bank at the crest was a capped, abandoned oil well. The area around the well also lacked vegetation, probably the result of effluent from the well (fig. 5).

The peak mean velocity of 7.7 feet per second in the spillway during the flow event is less than the permissible velocity of 8 feet per second for this site when the vegetation is in uniformly good condition, so no damage should have occurred to the spillway.<sup>4</sup> Damage to the spillway was minor and occurred only in previously weakened areas.

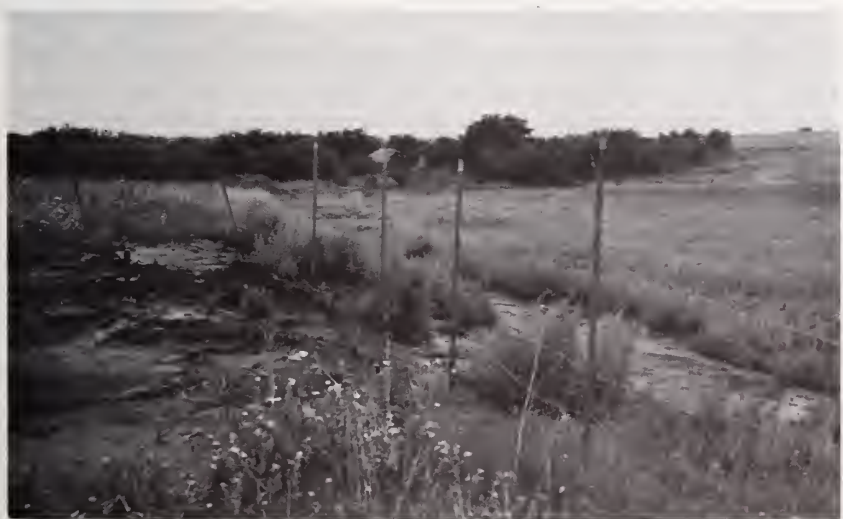
FIGURE 5.—Capped, abandoned oil well (to left) alongside crest of emergency spillway and barren strip (to right) on spillway crest.

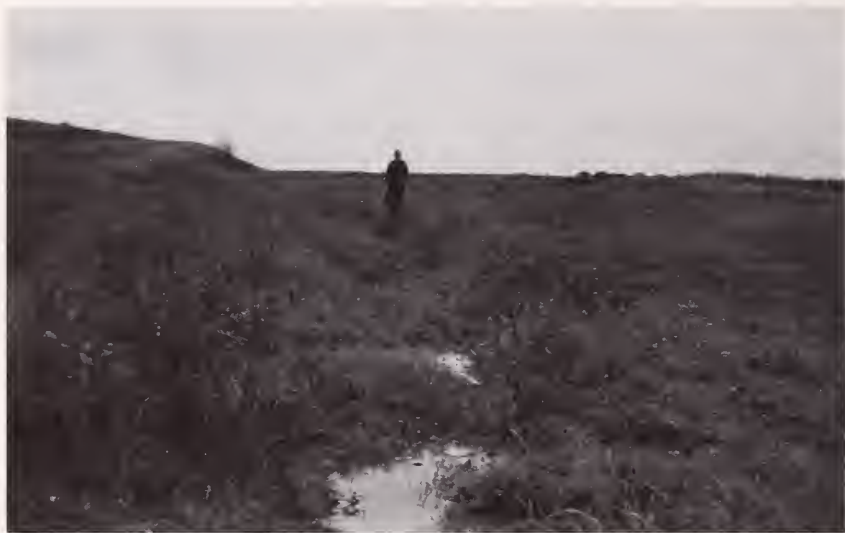
FIGURE 6.—Healed, small gully to right of lower end of emergency spillway.

A healed gully with minor erosion was observed along the right side of the lower part of the spillway (fig. 6). The old gully probably formed before a complete grass cover had been established. There is a possibility that this portion of the emergency spillway bottom was in a filled area. The "as built" plans for this structure showed that, in this vicinity, the spillway grade was actually built higher than was called for in the original plans. However, it is not known for certain that this was a filled area.
